REBULLA SURVEYORS SAS

SURVEY REPORT-DRAFT

" LIGER "

We have been asked to carry out the survey of the catamaran at issue in the Marina Monfalcone, in order to check a list of warranty issues (enclosure 03) before the beginning of the reparation works.

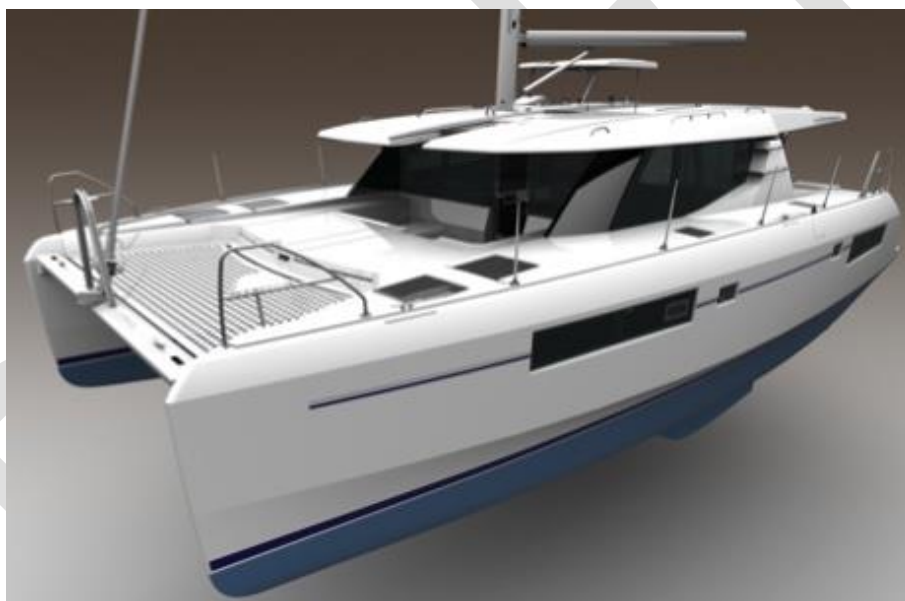
Our surveyor performed the inspection with the yacht ashore (picture 1) in the Marina Monfalcone in not ideal weather conditions (rain); furthermore, the surfaces had not been cleaned and a lot of stuff was stored on board, which did not allow a complete and easy check.
